# **A Characterization of Historic Properties along Bridge Boulevard from the Rio Grande to Coors Boulevard**

**Bernalillo County, New Mexico**

**FINAL  
APRIL 2012**

By  
Van Citters: Historic Preservation, LLC  
Albuquerque, New Mexico

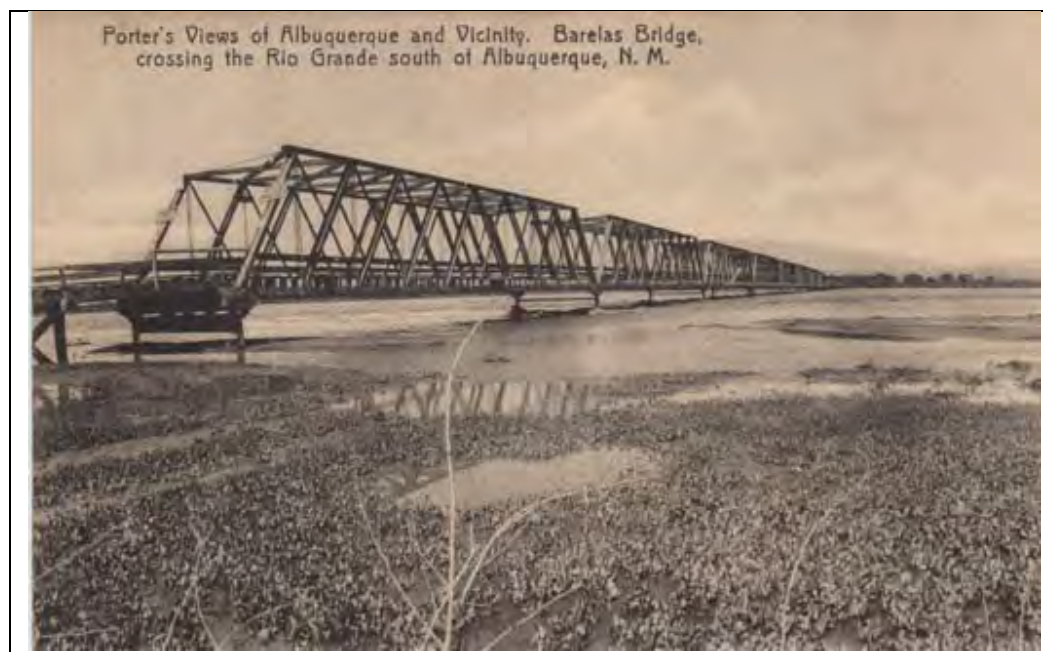
**Figure 3: Barelás Bridge in 1910.**

Although the river had been crossed since the earliest settlements, it was not until 1876 that the first bridge in Albuquerque was constructed. The bridge connected Albuquerque to the northern part of Atrisco, and was a pontoon constructed at the same location as the current Central Avenue bridge. The first permanent bridge opened on December 12, 1882. The permanent bridge was located near the pontoon, and was constructed of wood—the crossing toll was a nickel. Both the wooden bridge and pontoon were destroyed by floods in May 1891. It was not until nearly 20 years later, in 1910, that Albuquerque replaced the wood bridge with the Barelás Bridge, a steel truss structure with a wood roadbed (<http://www.albuqhistsoc.org>) (Figure 3). This truss bridge was flooded and rebuilt in 1912, and by 1920 a new concrete structure was constructed adjacent to the steel truss. By the 1950s the truss structure had been removed and only the concrete crossing remained (Figure 4).

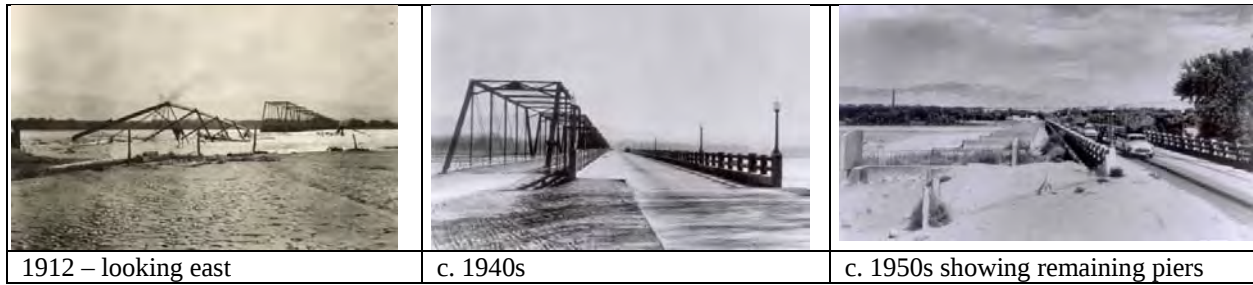
**Figure 4: Historic bridge photographs. 1) 1912 after flood; 2) c. 1940s after the concrete bridge was constructed adjacent to the steel truss; and 3) c. 1950s after the steel truss had been removed, but the piers remained in the river.**

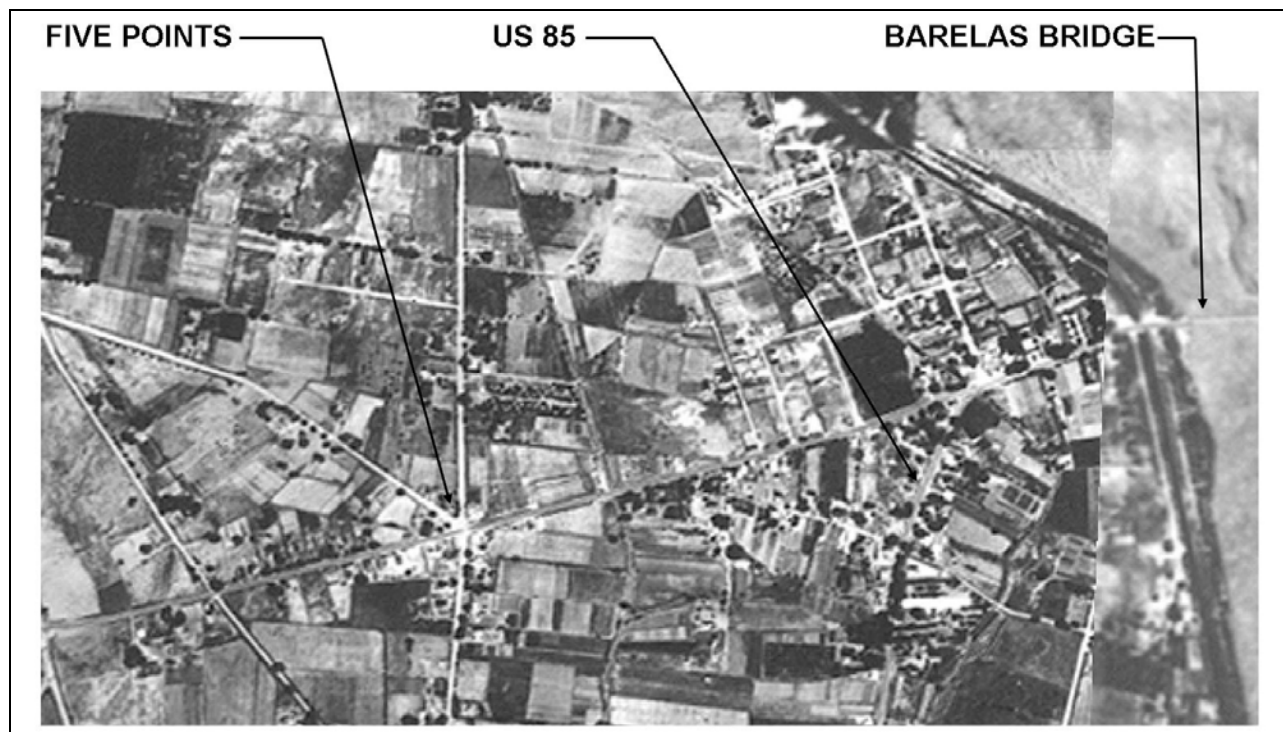
Figure 7: Aerial of Atrisco area in 1935 showing Five Points, agricultural fields, the Atrisco Drain, acequias and development along US 85 and the west abutment of the Barelbas Bridge.

initial routing of US 85 and Route 66 used existing roads and their associated infrastructure, including the Barelas Bridge and a portion of what we now know as Bridge Boulevard. It can be presumed that once the road received the designation of “US 85,” new commercial development began to show up along the corridor (Figure 7 and Figure 8).

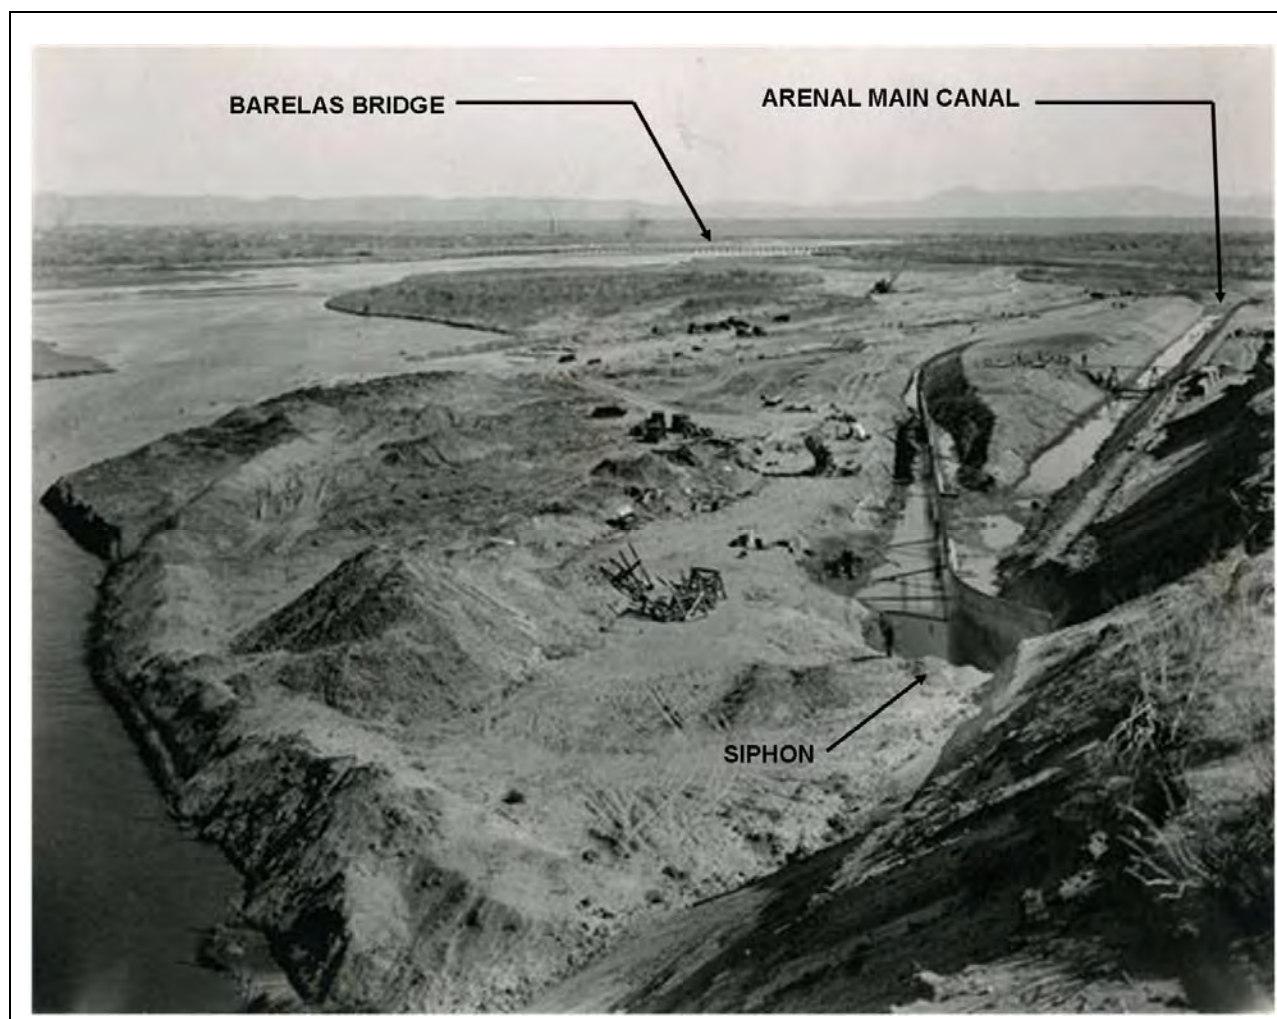
**Figure 9: Construction of the Arenal Main Canal showing where the siphon opens after crossing the Rio Grande. Looking south towards the Barelas Bridge.**

The Atrisco unit of the MRGCD (the Bridge Boulevard project area is within this unit) is in the Albuquerque Division, which was served by the Angostura Diversion Dam, near Algodones. The irrigation supply canal ran from Algodones along the east side of the river; water was transferred to the west side Atrisco and Pajarito units via a siphon under the Rio Grande, just north of the Central Avenue bridge (Figure 9). The canal on the west side of the river, called the Arenal Main Canal, ran as far west as Coors Boulevard and supplied water to the Ranchos de Atrisco Acequia, Arenal Acequia, and Atrisco Acequia. The drains include the Atrisco Riverside Drain, Atrisco Drain and Isleta Drain—these drains ensured that water-logging did not occur and transferred excess water from the fields and areas of high water table back to the Rio Grande.

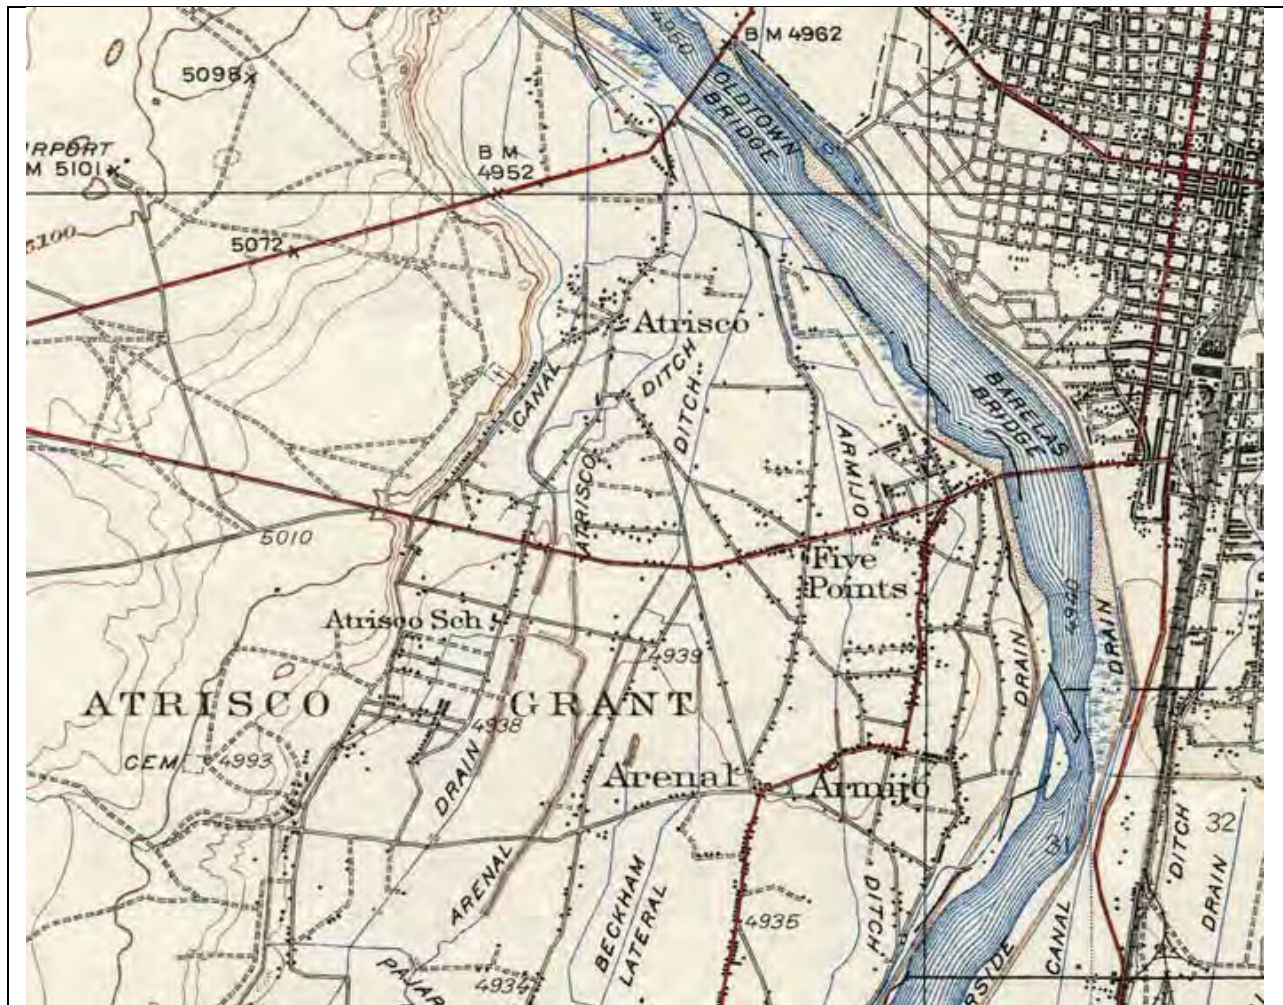
Figure 10: 1937 topographic map showing the project area roads, bridge development and MRGCD works.

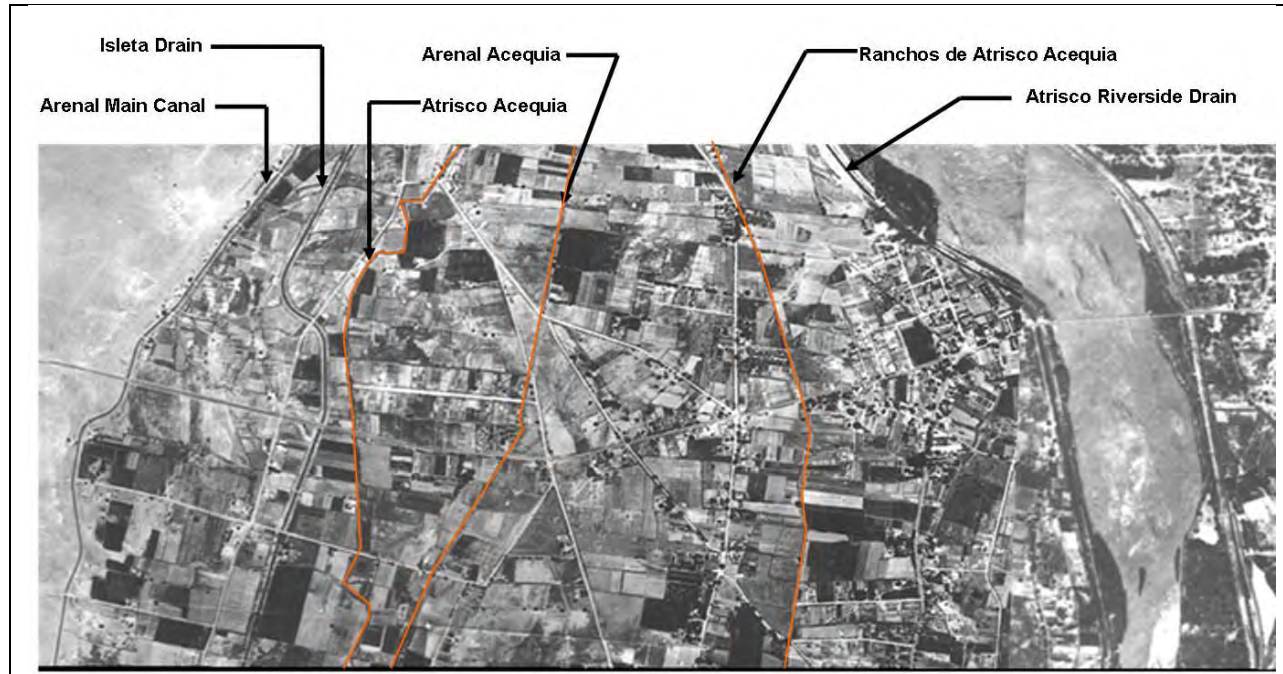
**Figure 11: 1935 aerial photograph showing entire length of project area with canals, drains, *acequias* and fields.**

The MRGCD features that cross the project area include the Arenal Main Canal, the Ranchos de Atrisco Acequia, Arenal Acequia, and Atrisco Acequia, the Atrisco Riverside Drain, and the two internal drains, the Atrisco Drain and Isleta Drain (Figure 11).

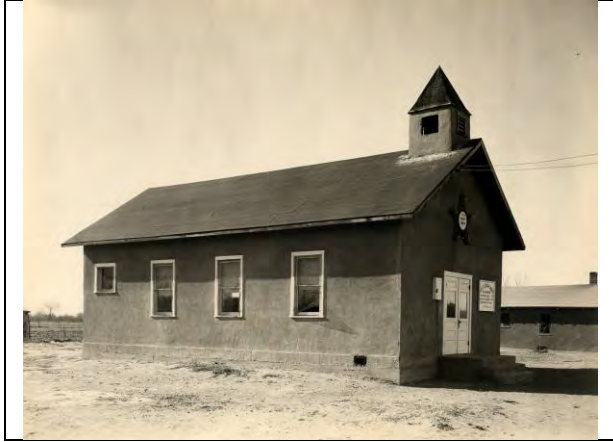
**Figure 12: Five Points Church c. 1930.**

these vernacular buildings along the corridor are eligible, they would most likely be eligible at the local level of significance. One building of particular note is the Five Points Church which is now a boxing gym (**Figure 12**). It seems that until the 1950s, this area was primarily rural in character with scattered homes between fields and *acequias* (**Figure 13**).

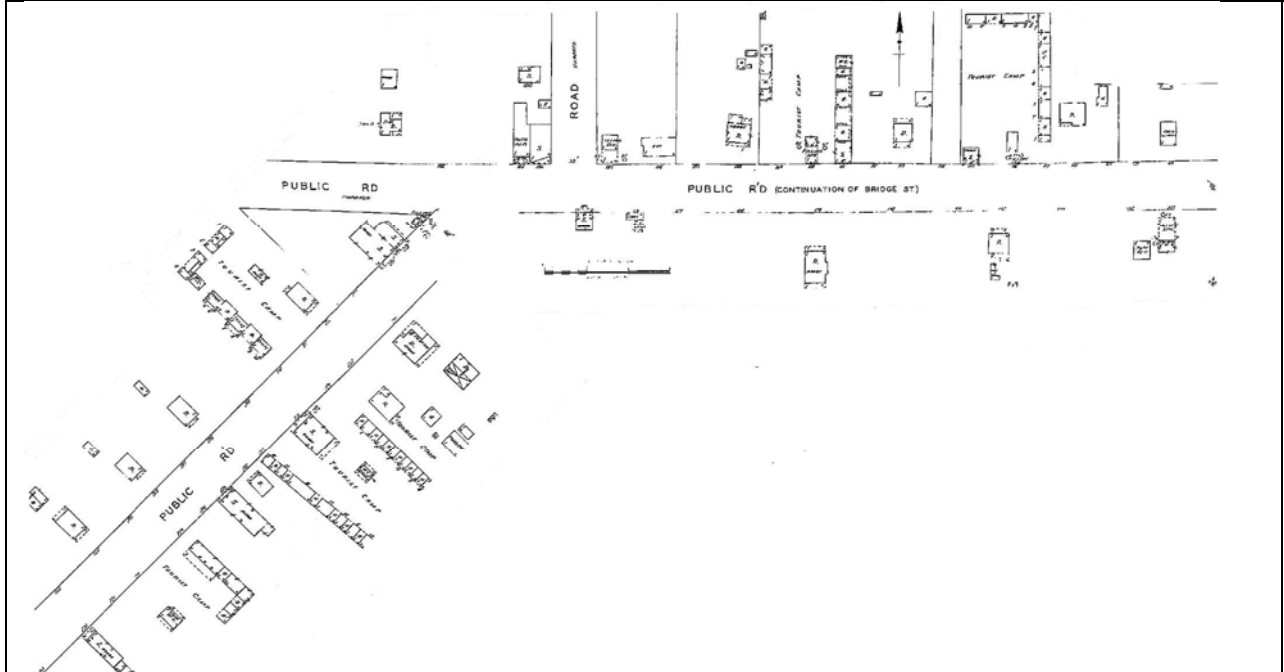
**1931: Sanborn Map of the unpaved public road that would become Bridge Street. The river crossing is just to the right of this map.**

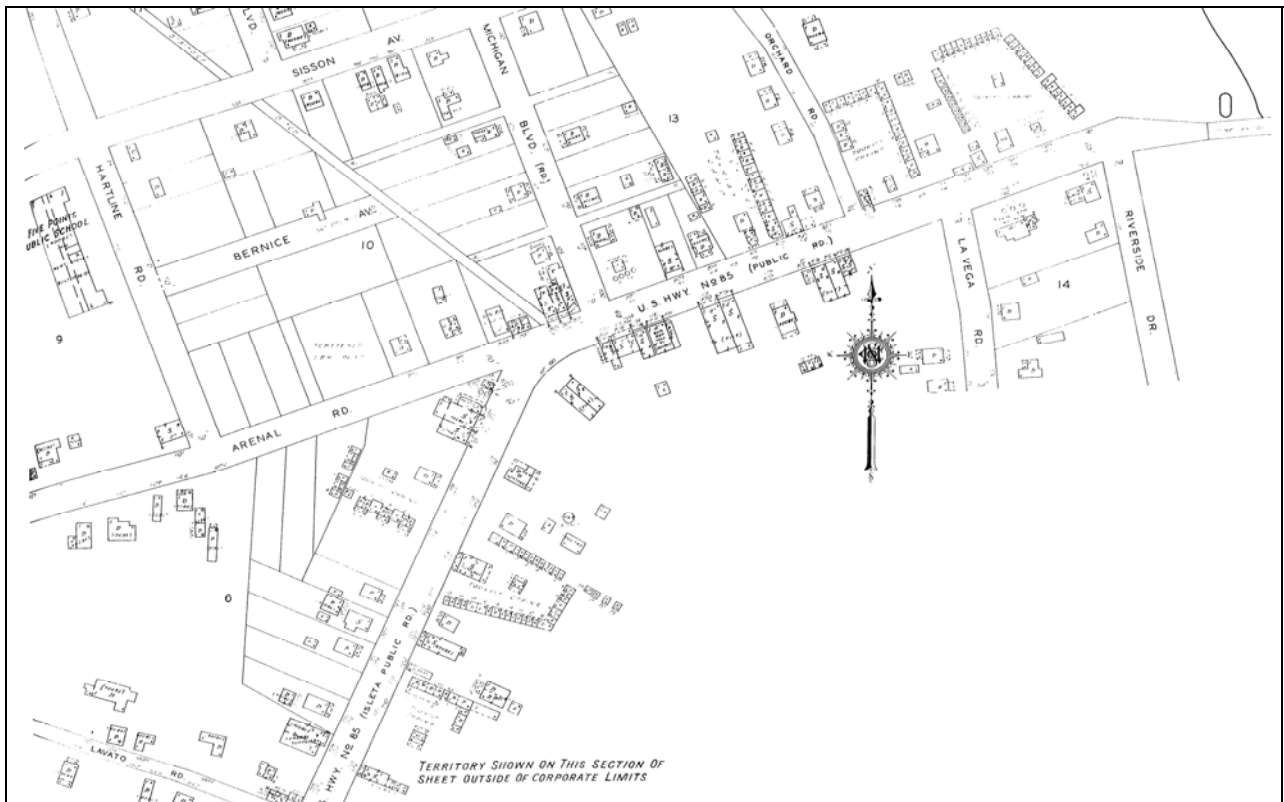
**1942: Sanborn Map of US Highway 85, a public road (also known as Arenal Road farther west) – this eventually became known as Bridge Street. The river crossing is just to the right of the map. Note the tourist courts and more dense commercial development along the US 85 portion of the road.**

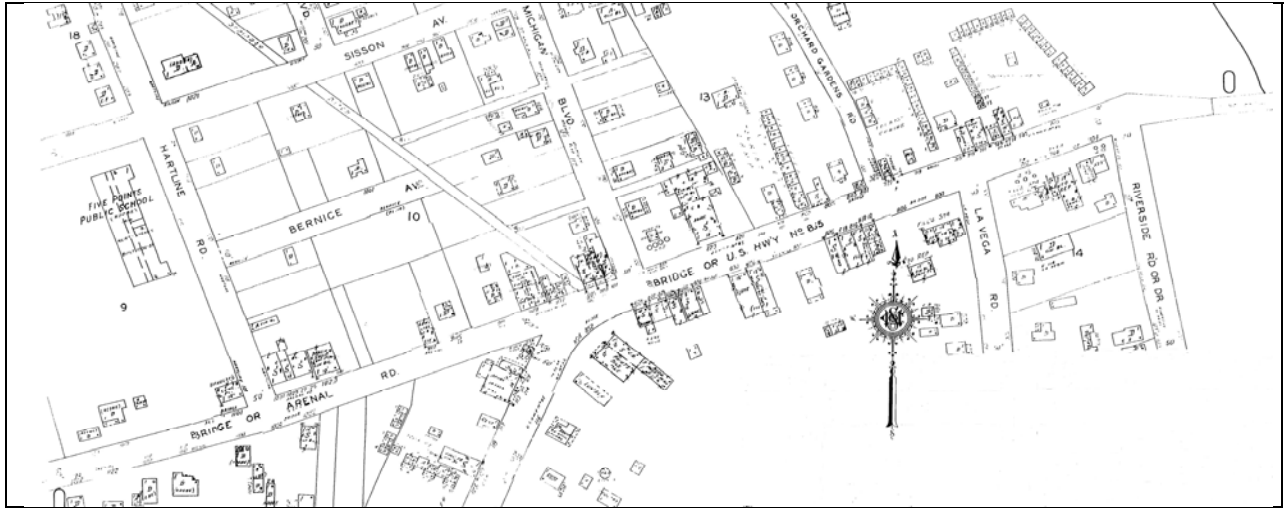
**1951: Sanborn Map of US Highway 85, also known as Bridge by 1951 (farther west the road was also known as Bridge or Arenal Road). The river crossing is just to the right of the map. Note the tourist courts and more dense commercial development along the US 85 portion of the road.**

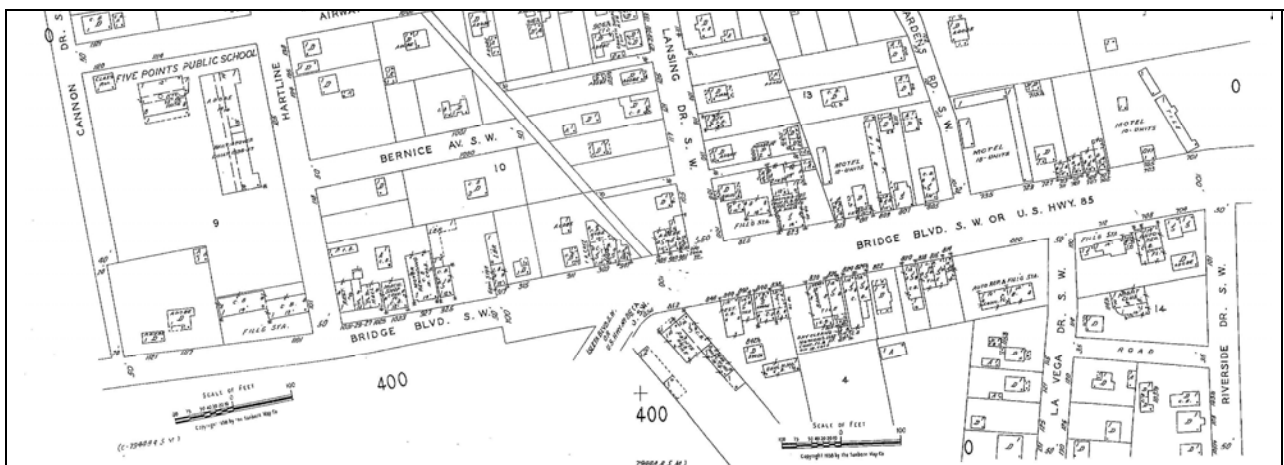
**1957: The Sanborn detail map still only shows the portion of Bridge closest to the river. Note that this is the first map to show an irrigation ditch.**
